**TOPIC:** degradation of **polymeric insulation** for **HVDC** cable application properties.

**GOAL:** investigate the **ageing** behavior of polypropylene-based insulation containing artificial **voids** under HVDC stress characterizing by the means of **Space Charge** and **Partial Discharge** measurements at different ageing stages.

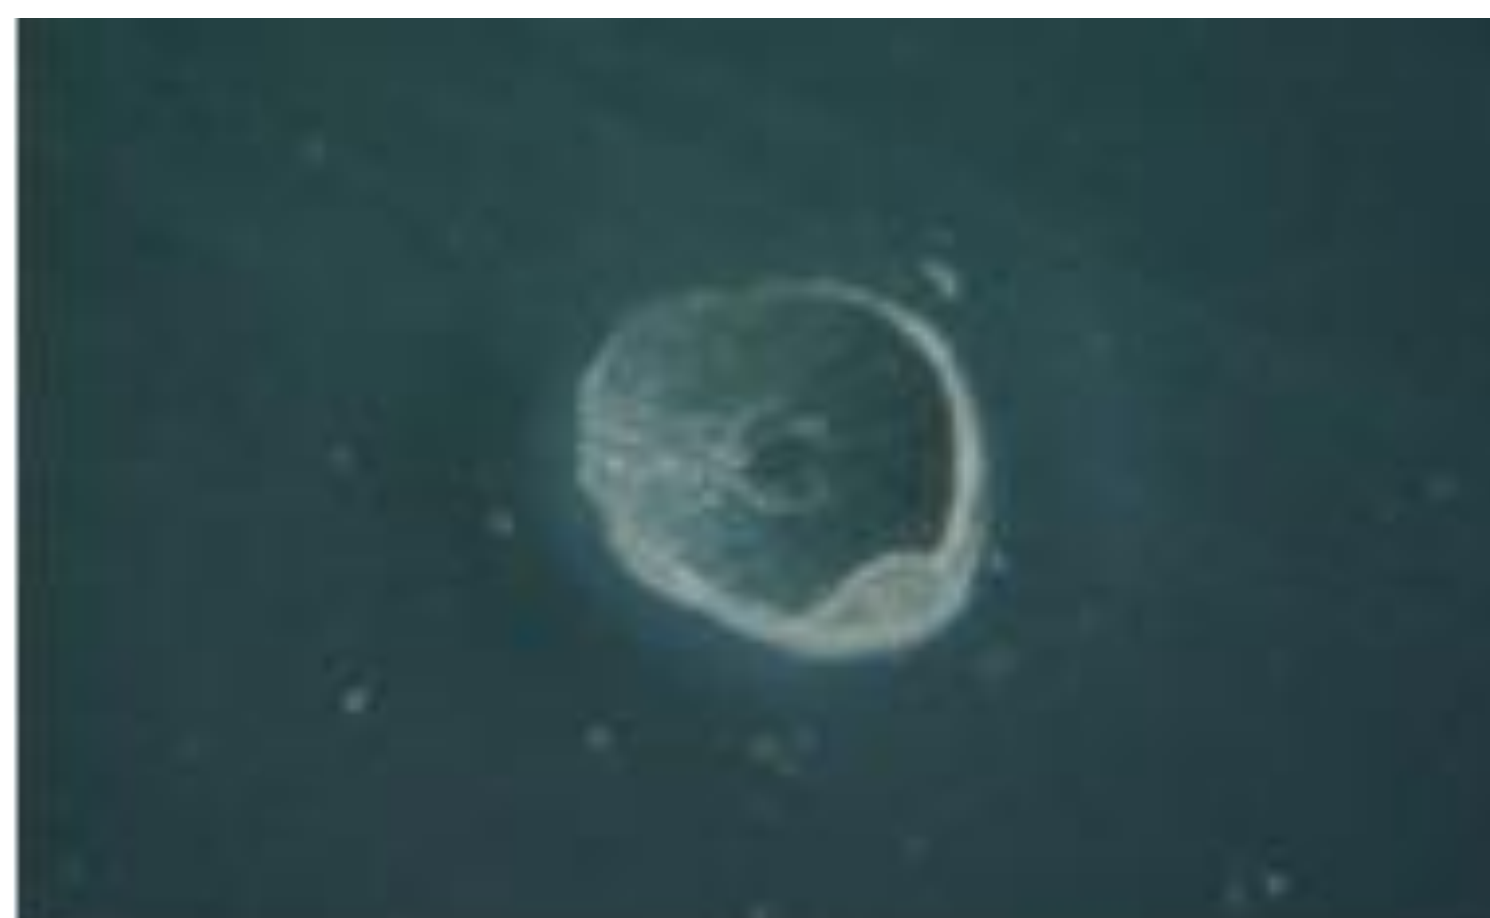
Fig. 1 - PP specimen with defect (void).
